**To:** Seville Building 8  
**From:** Leo Cannyn, PMP, P.E., Principal Project Manager  
**Subject:** 2612 Pearce Dr. Clearwater, FL 33764 Engineering Affidavit for Milestone  
Inspection Phase 1  
**Date:** 6/19/2023

Beryl Engineering & Inspection, LLC ("Beryl") was retained by Seville Building 8 with regards to the inspection located at 2612 Pearce Dr. Clearwater, FL 33764. According to the Pinellas County Property Seville BuilAppraiser Website, the building was built in 1971. The structural systems are consistent with a Slab-on-Grade foundation with Concrete Masonry Units (CMU) walls clad in Stucco veneer. The roof structure is consistent with Trusses and Plywood sheathing with a predominantly Flat roof with SPF. The mansard roof is built with concrete/clay tiles.

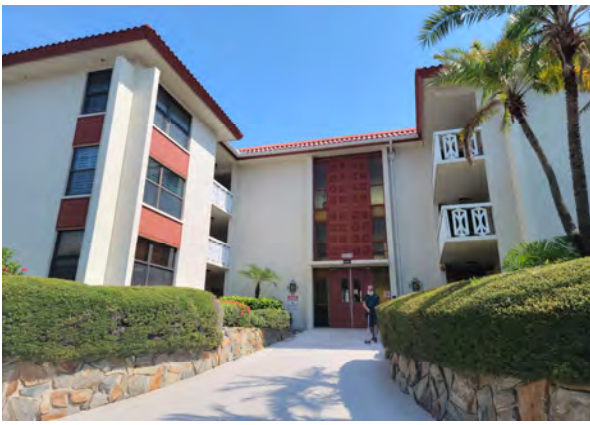
1 Front of Building

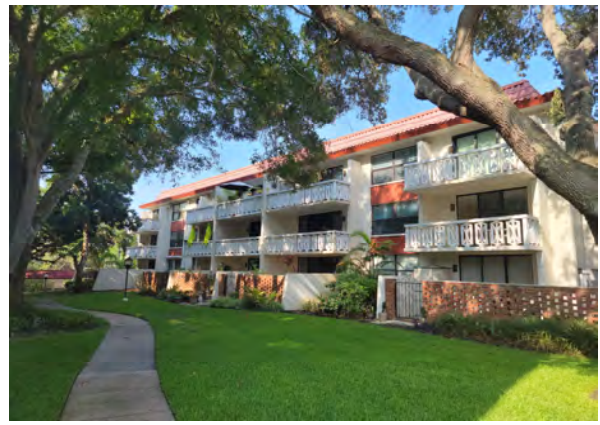
2 Right Side of Building

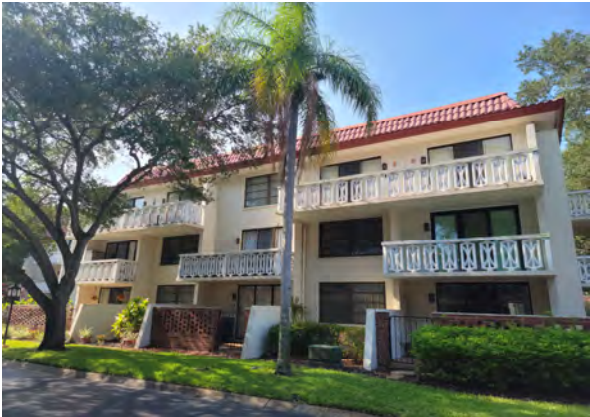
3 Rear Side of Building

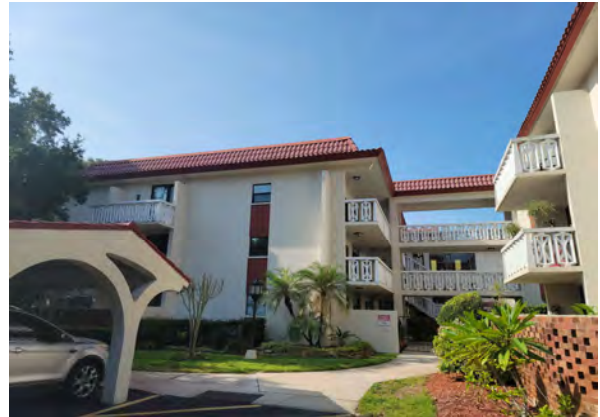
4 Left Side of Building

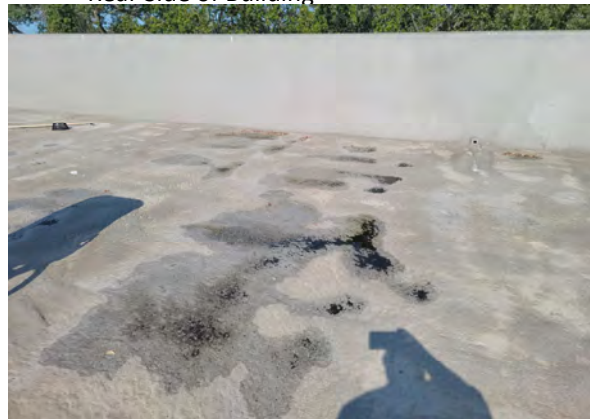
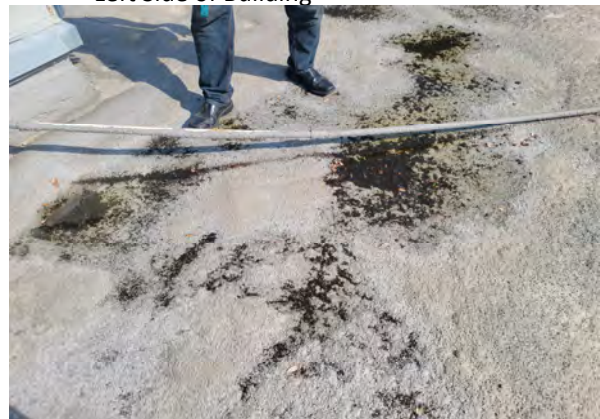
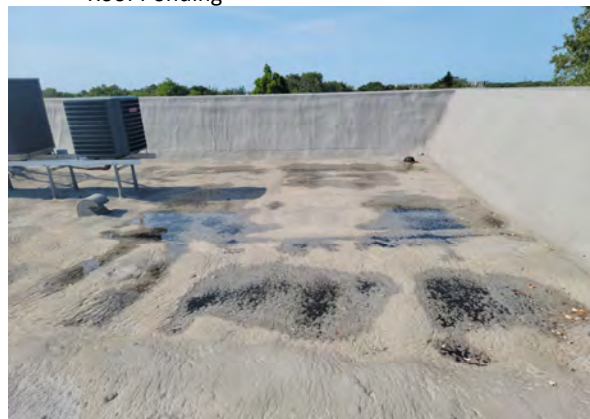
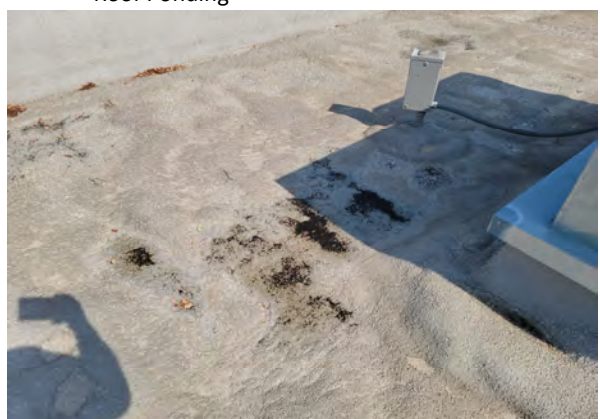
Beryl also found multiple areas of ponding on the roof along with reviewing repair proposals to attend to the defects found on the roof. Beryl recommends proceeding with the repair protocols outlined in that proposal.

5 Roof Ponding

6 Roof Ponding

7 Roof Ponding

8 Roof Ponding

Beryl further recommends maintaining the roof scuppers so that they are clean and draining all the water off the roof as this can prematurely deteriorate the roofing system. Furthermore, Beryl recommends creating and or keeping a rigorous maintenance schedule to help preserve the building's integrity.

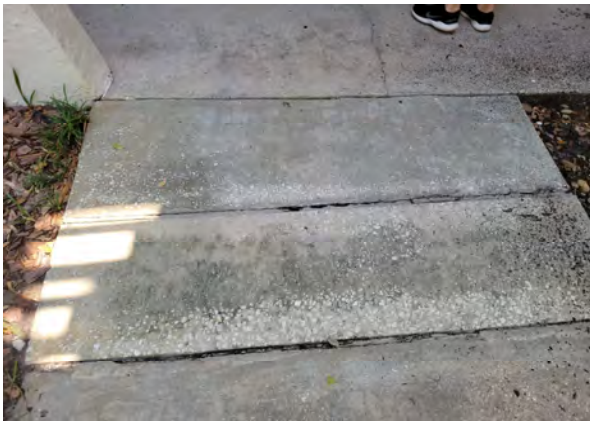
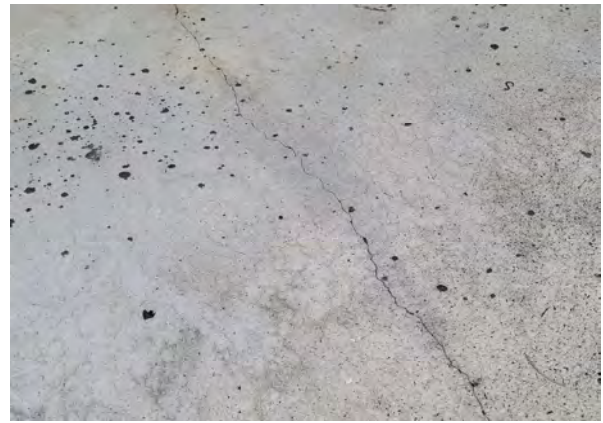
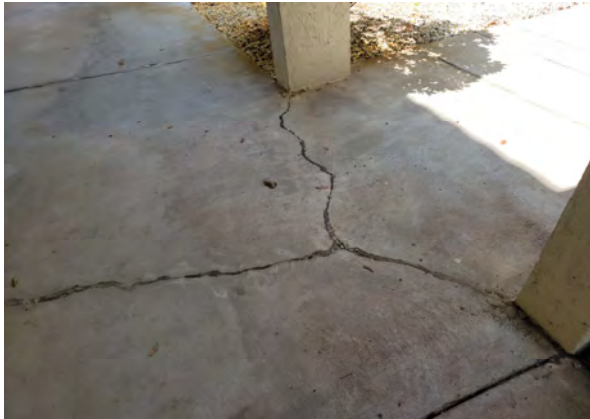
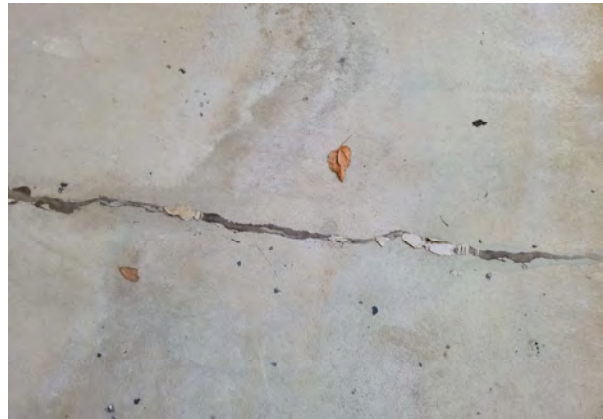
At the time of inspection, Beryl found multiple areas that needed maintenance. These deficiencies were found in the walkways around the property in the form of cracking due to shrinkage and or minor settling. These cracks should be sealed to help prevent water penetration and ensure proper drainage away from the building to help prevent rapid settlement. These cracks were also noted in the balcony guardrails and carport columns which should be repaired. Beryl recommends that the building is repainted this coming year in order to address these concerns. At that time, the cracks can be remediated using elastomeric caulking and sealing.

9 Cracked Concrete

10 Cracked Concrete

11 Cracked Concrete

12 Cracked Concrete

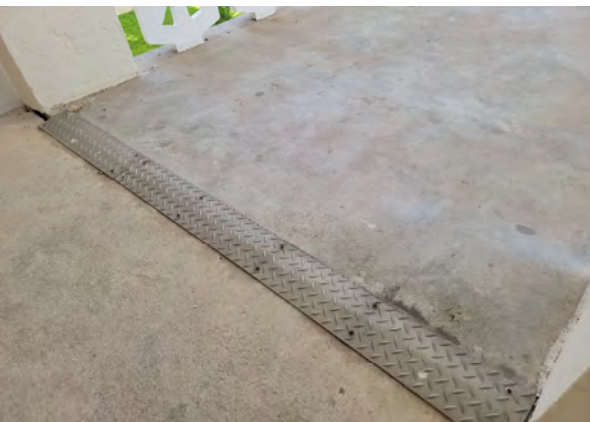
13 Breezeway Separation Location

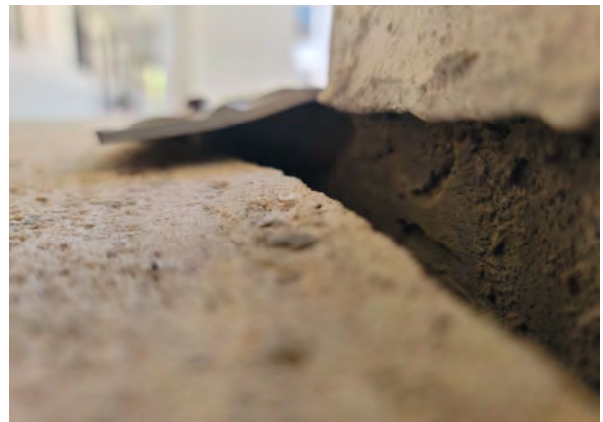
14 Side View of Separation

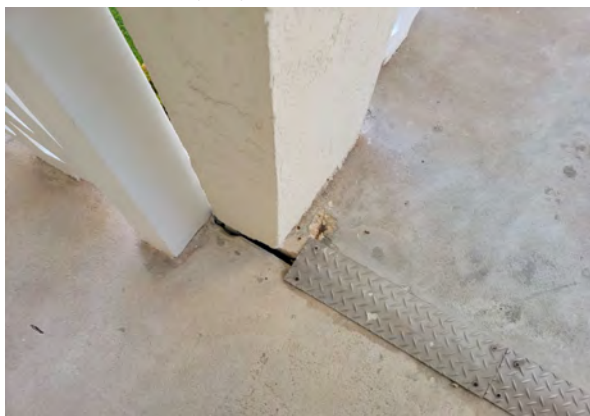
15 Gap at Column Overview

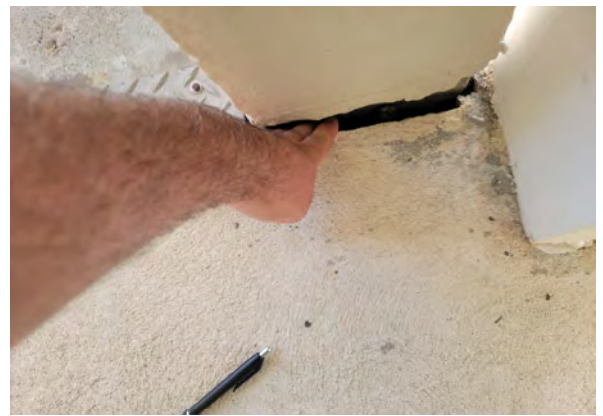
16 Gap at Column

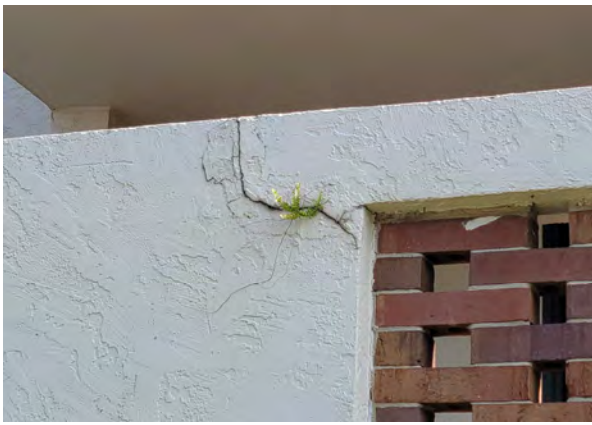
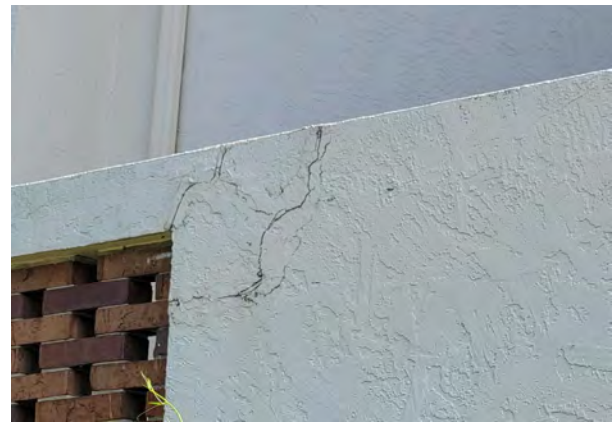
17 Cracks in Patio Wall

18 Cracks in Patio Wall

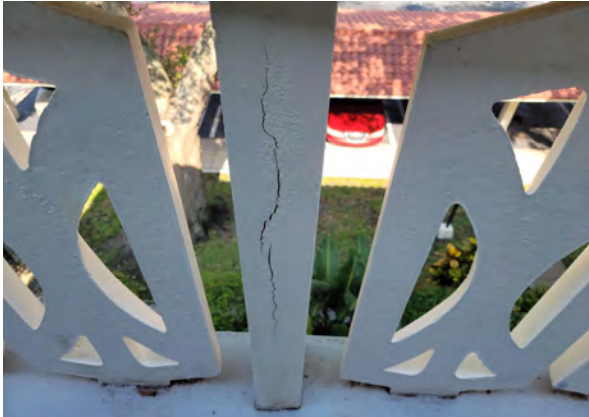
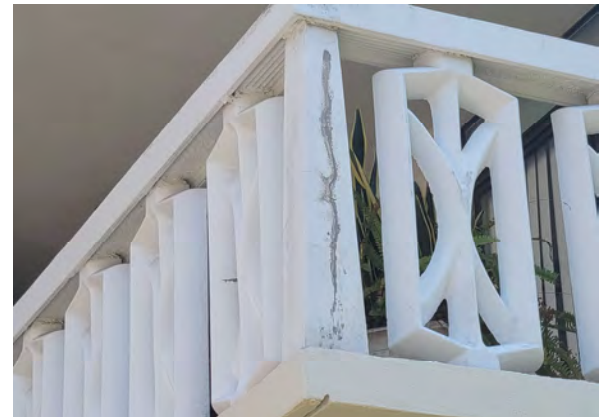
19 Support Column Crack

20 Support Column Crack

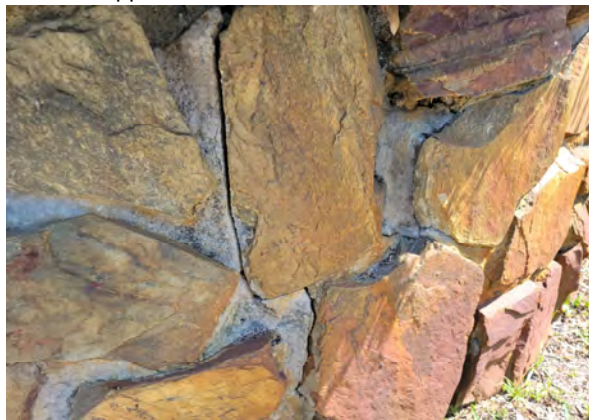
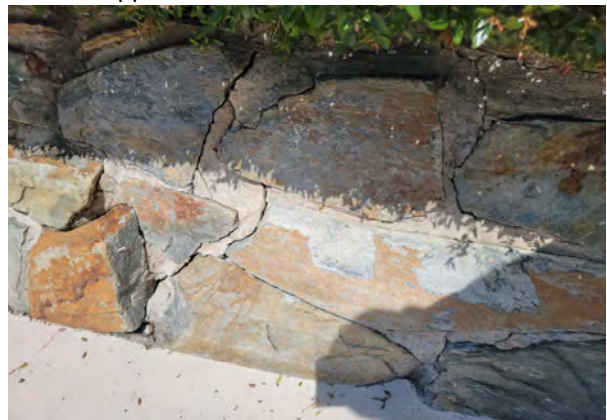
Beryl also noted some cracks in the retaining wall around the front of the property. These cracks need to be repaired to ensure the retaining wall will continue to hold the soil back. Due to the age

21 Retaining Wall Crack

Retaining Wall Crack

of this wall along with the amount of damage found, Beryl is recommending replacement at this time.
