## **Reserve Study**

Prepared for the Board of Directors for the  
**Seville Building 8**

2612 Pearce Dr, Clearwater, Florida 33764

**December 6, 2024**

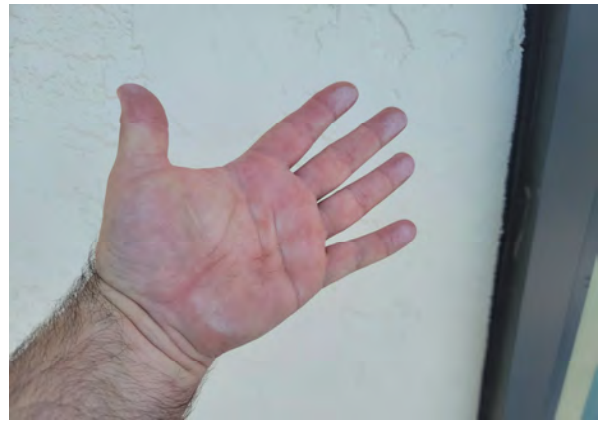
26 Exterior Paint Chalking
