## **Reserve Study**

Prepared for the Board of Directors for the  
**Seville Building 8**

2612 Pearce Dr, Clearwater, Florida 33764

**December 6, 2024**

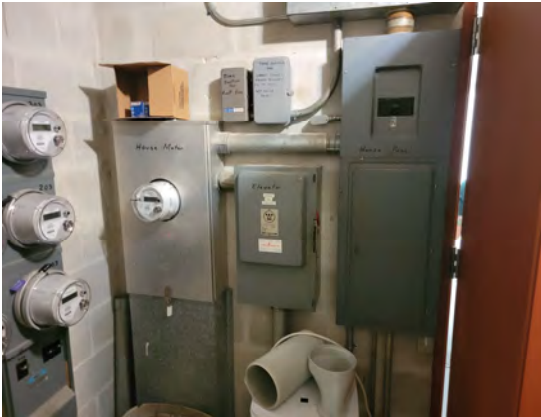
74 Meter Bank and Disconnect

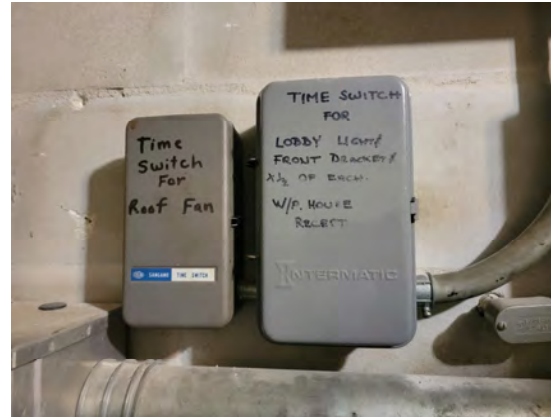
75 Meter Bank and Disconnect

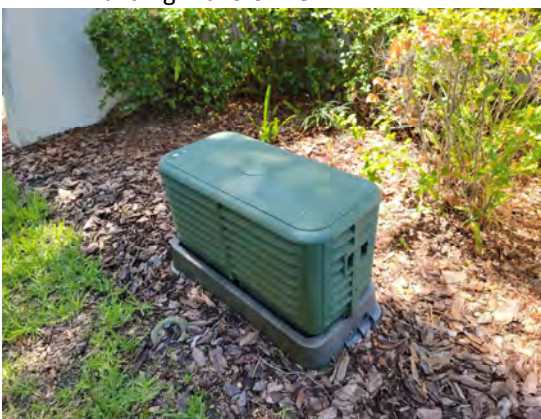
78 Main Water Shut Off

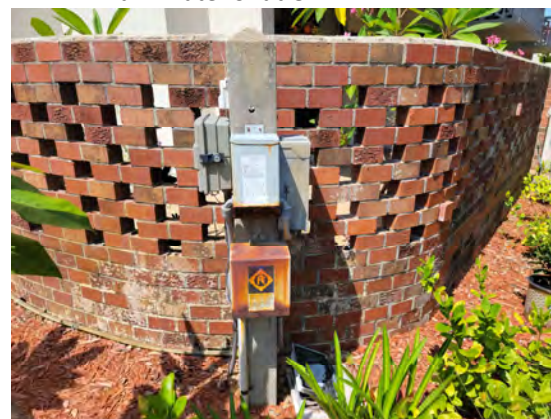
79 Cable Connection Box
